443 Madison St
Toronto, ON

PREPARED FOR
JOHN SIMPSON

INSPECTION DATE
Sunday, March 10, 2019

Report No. 3284, v.6

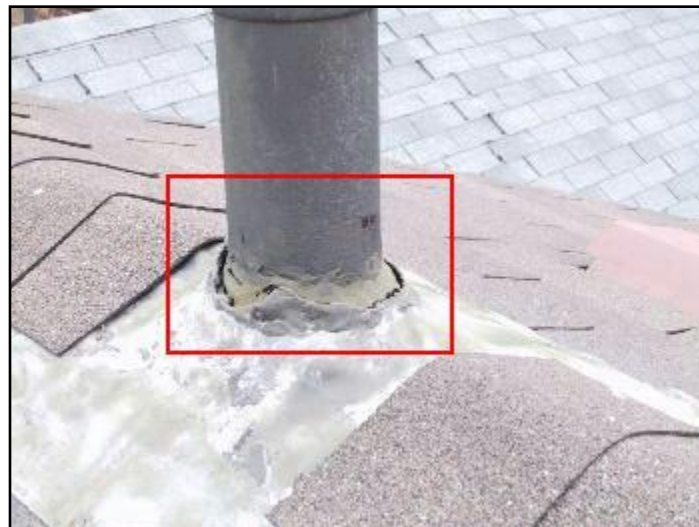
Condition: • [Leak](#)

Implication(s): Chance of water damage to structure, finishes and contents

Location: North

2. Leak

Task: Repair

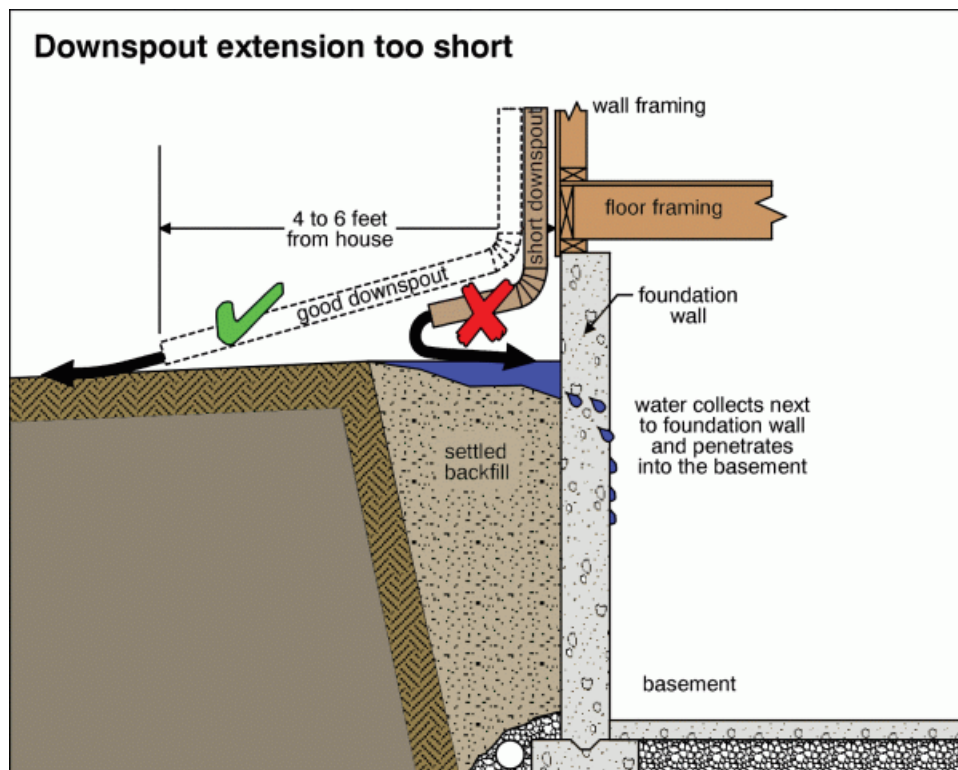
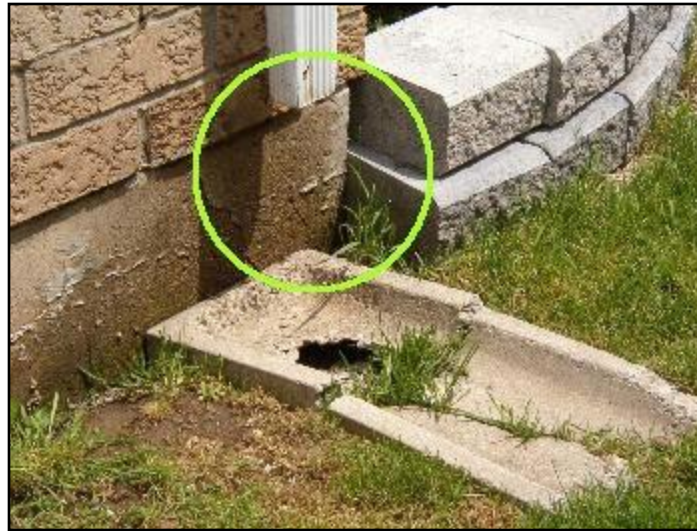
Condition: • [Discharge too close to building](#)

Implication(s): Chance of water damage to structure, finishes and contents

Location: East Exterior Wall

3. Downspouts discharge too close to building

The downspout should be extended to discharge at least 6 feet from the home. The splash block can be discarded.

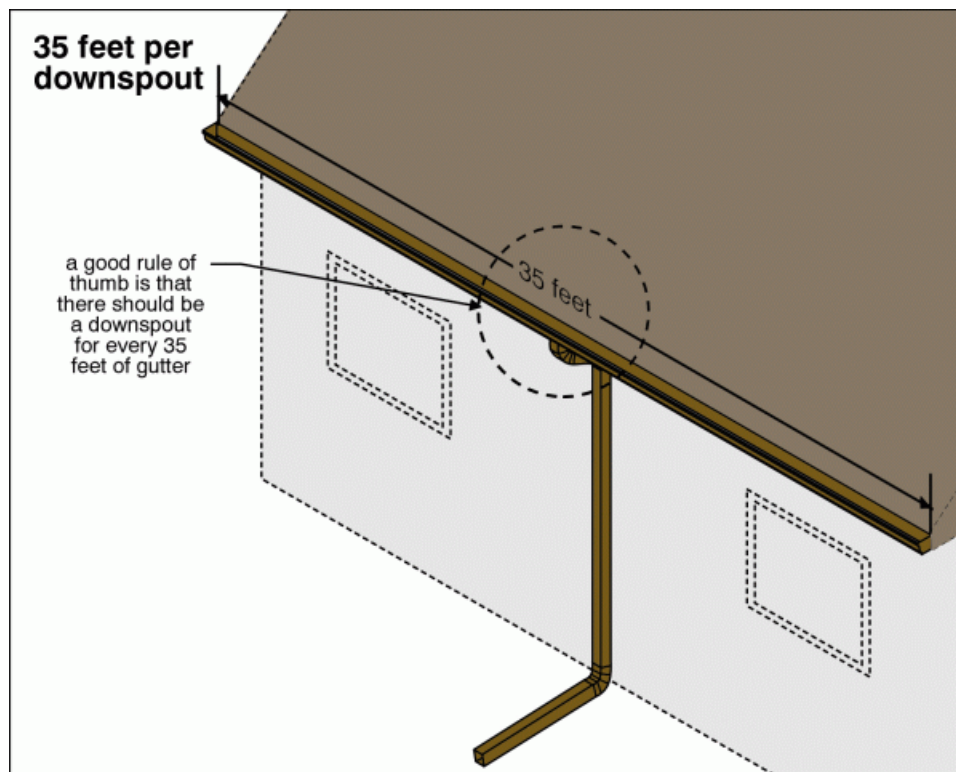
Condition: • [Too few](#)

Implication(s): Chance of water damage to structure, finishes and contents

Location: Various

More downspouts will help reduce the risk of basement flooding.

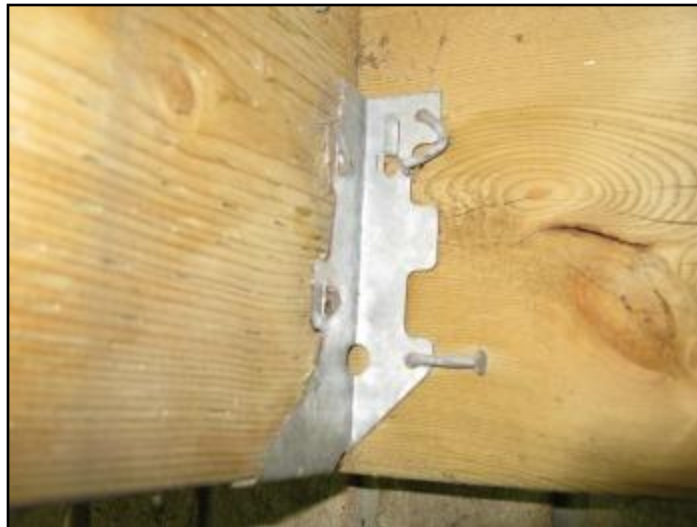
Condition: • [Fastener problems](#)

Joist hangers for wood deck are not properly secured.

Implication(s): Weakened structure | Chance of movement

Location: North Exterior Wall

4. Poor end bearing, joist hanger connections

Task: Improve

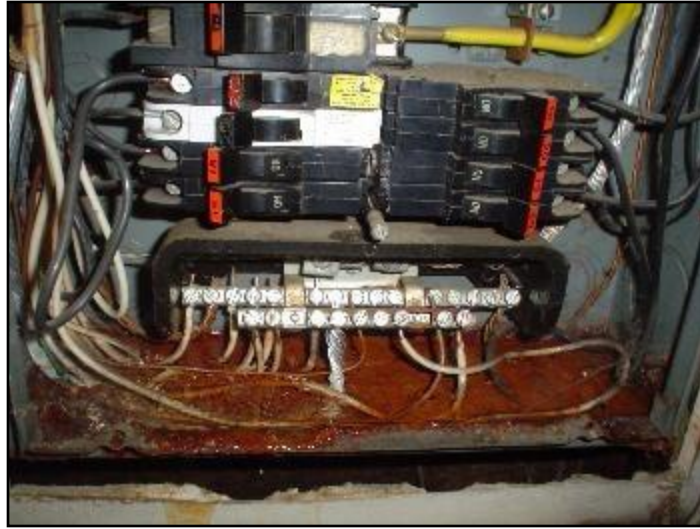
Condition: • [Rust or water in panel](#)

Implication(s): Electric shock | Fire hazard

Location: North Basement

7. Water and rust in bottom of panel

Task: Replace

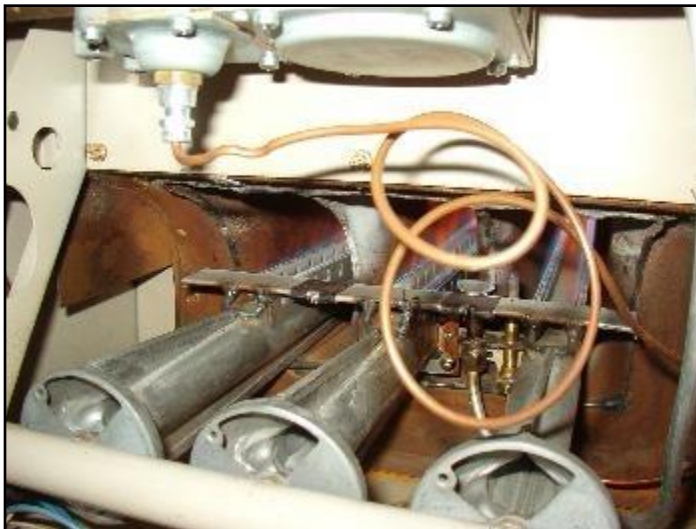
Condition: • [Draft hood spillage or backdraft](#)

A considerable amount of rust was noted on the front of the furnace.

This suggests a back-drafting problem, with combustion products entering the home.

This is often caused by lack of combustion air, but the corrective action should be determined by a specialist.

Implication(s): Equipment not operating properly | Hazardous combustion products entering home

9. Draft hood spillage or backdraft

Task: Correct

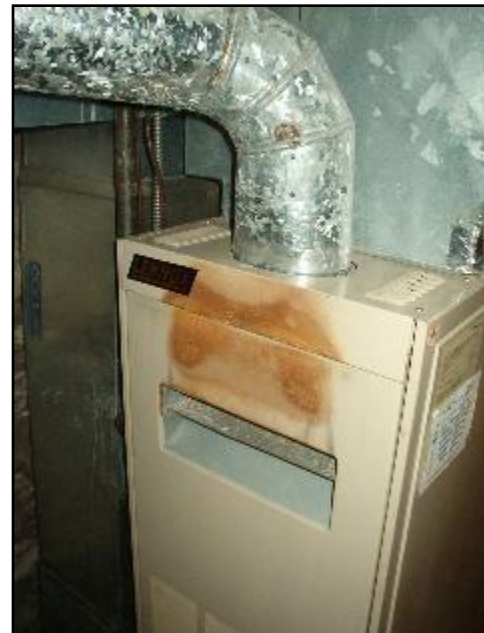
10. Draft hood spillage or backdraft

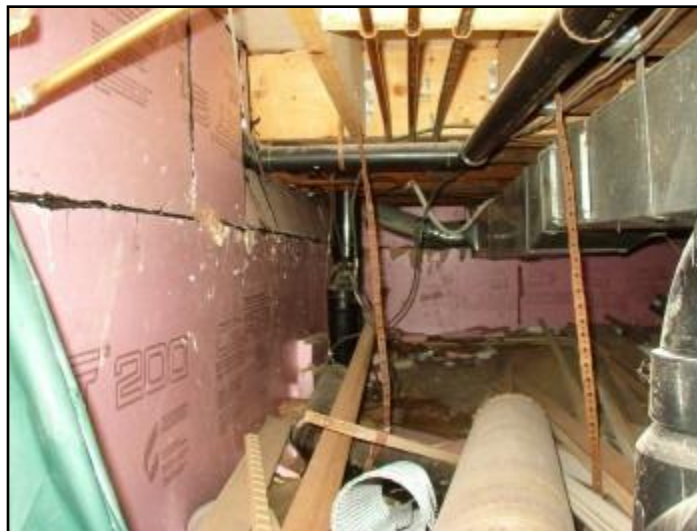
Condition: • [Exposed combustible insulation](#)

Implication(s): Fire hazard

Location: West Crawl Space

12. Exposed combustible insulation

Task: Remove or cover with drywall

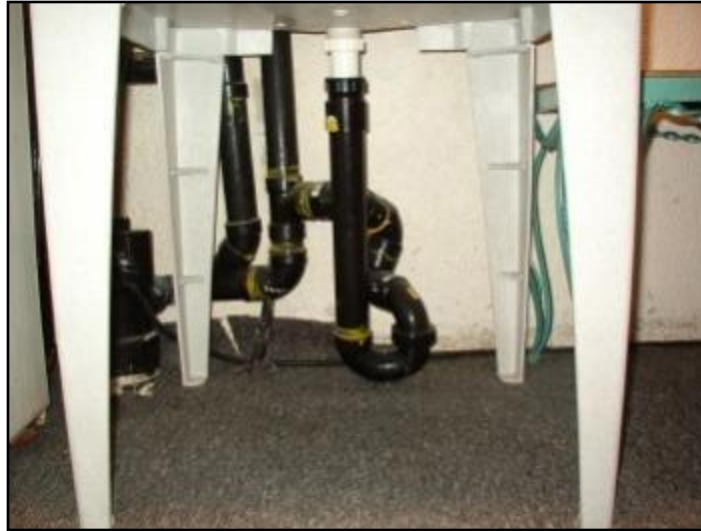
Condition: • [Nonstandard shape or material](#)

Implication(s): Reduced operability | Fixtures slow to drain

Location: Basement Laundry Area

14. Poor trap arrangement

Task: Improve

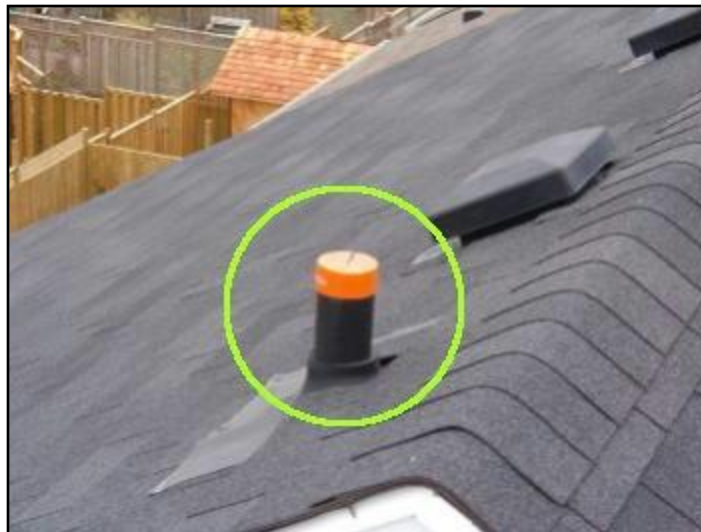
Condition: • [Vent termination problems](#)

Implication(s): Reduced operability | Sewer gases entering the building

Location: West central part of roof

15. Plumbing stack is capped

Task: Remove cap
