443 Madison St
Toronto, ON

INSPECTION DATE
Sunday, March 10, 2019

INSPECTED BY
Alan Carson, 23456

RE: Report No. 3284, v.6
443 Madison St
Toronto, ON

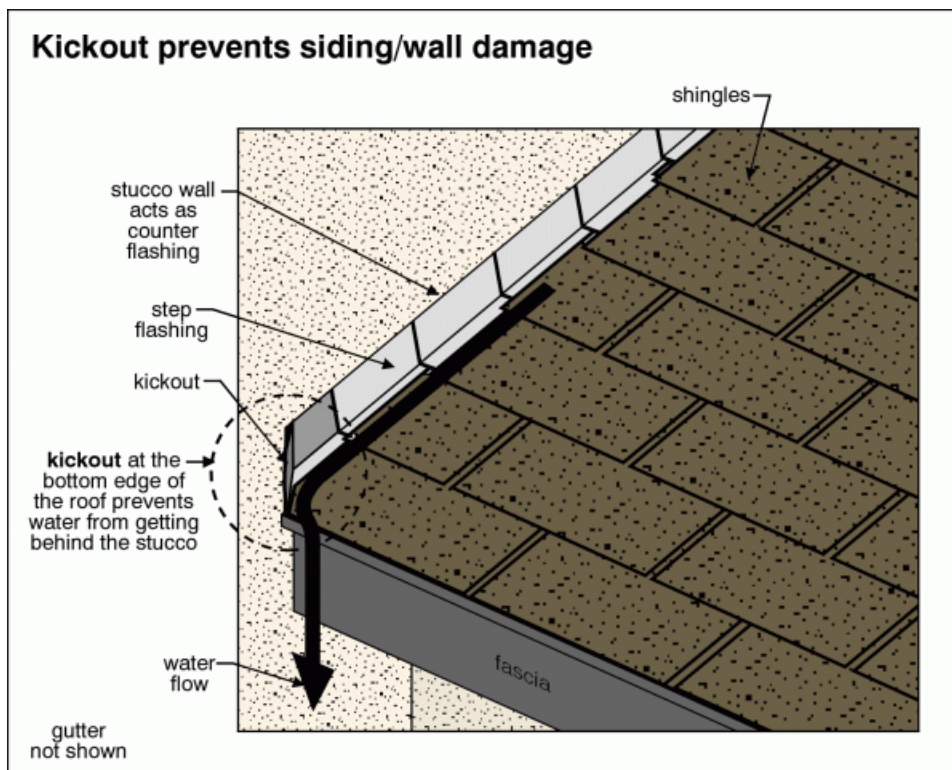
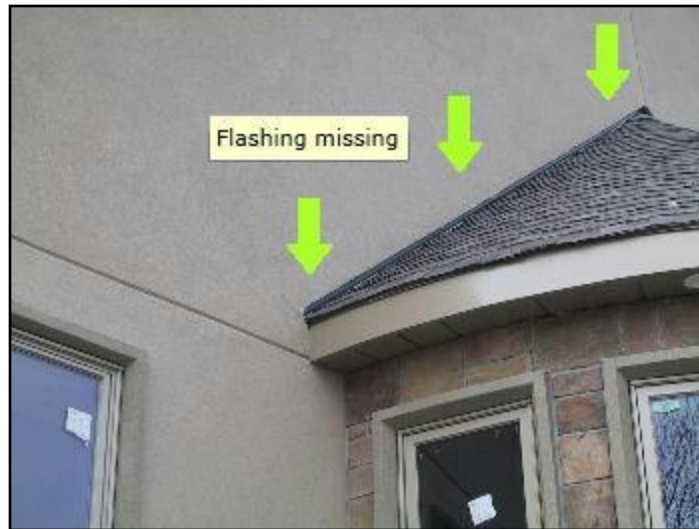
Condition: • [Kickout flashing - missing](#)

Implication(s): Chance of water damage to structure, finishes and contents

Location: North First Floor

1. No kickout flashing at roof/sidewall junction

Task: Improve

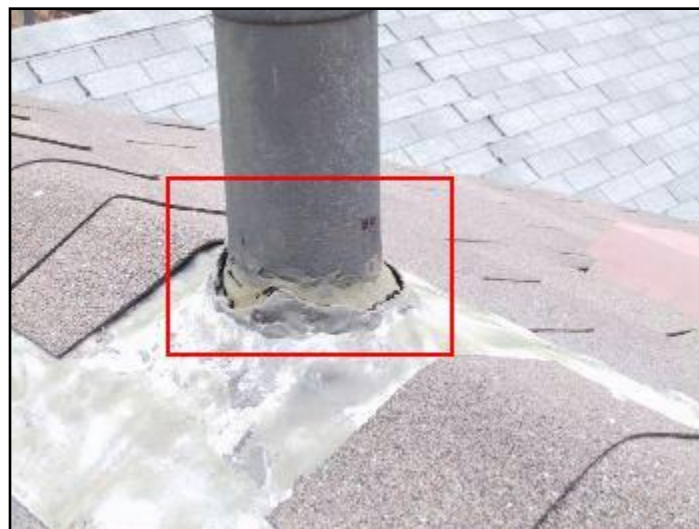
Condition: • [Leak](#)

Implication(s): Chance of water damage to structure, finishes and contents

Location: North

2. Leak

Task: Repair

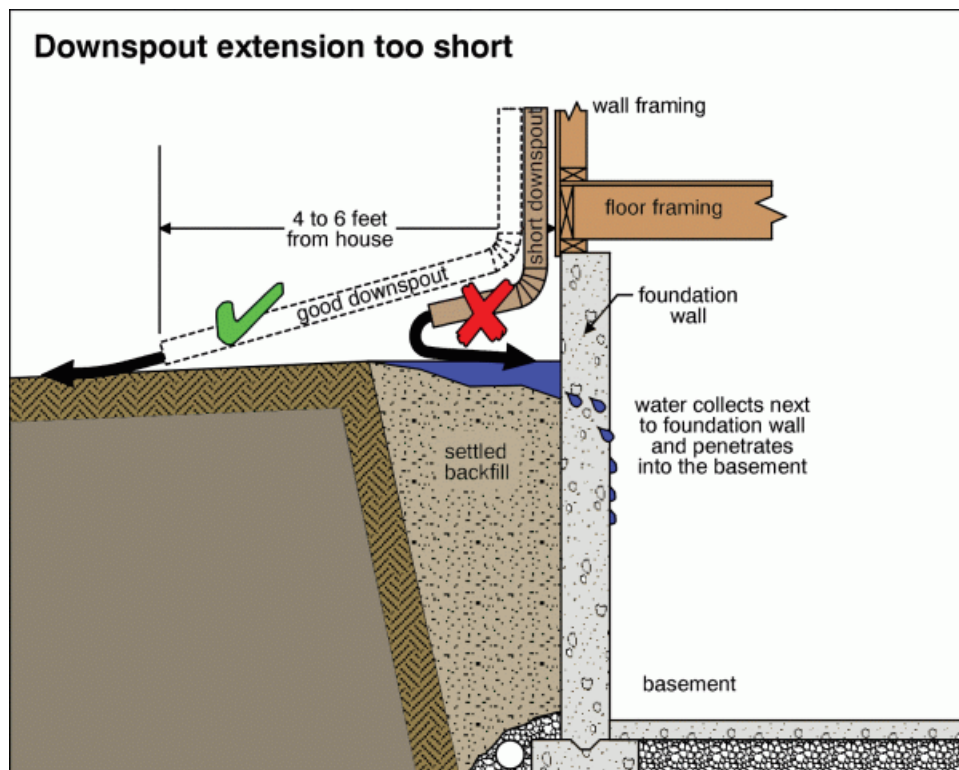
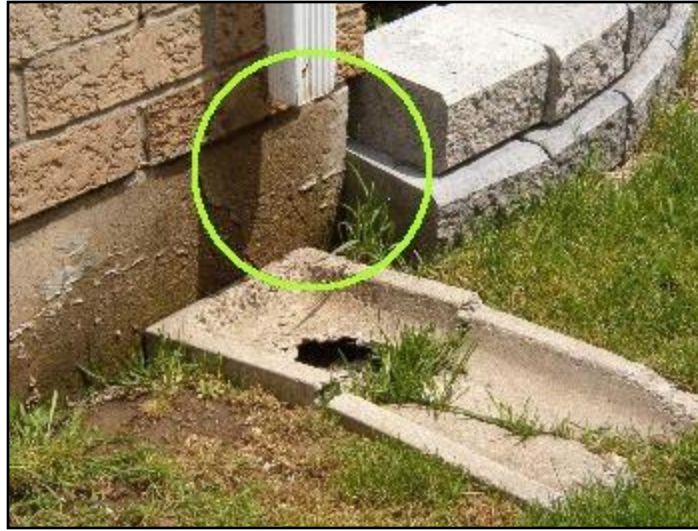
Condition: • [Discharge too close to building](#)

Implication(s): Chance of water damage to structure, finishes and contents

Location: East Exterior Wall

3. Downspouts discharge too close to building

The downspout should be extended to discharge at least 6 feet from the home. The splash block can be discarded.

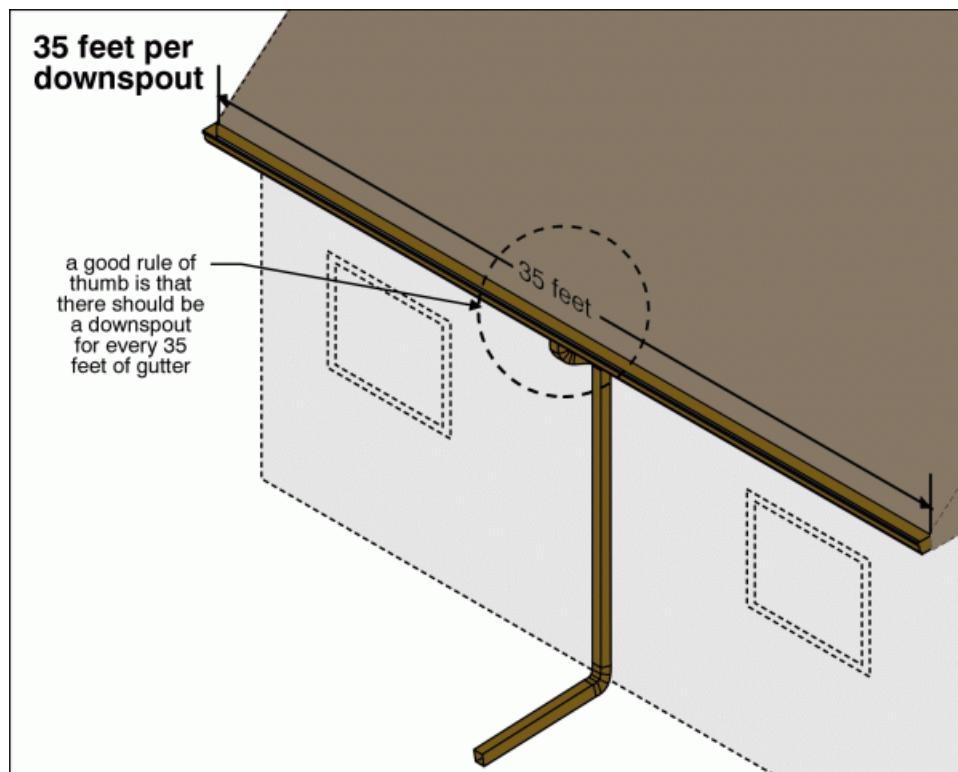
Condition: • [Too few](#)

Implication(s): Chance of water damage to structure, finishes and contents

Location: Various

More downspouts will help reduce the risk of basement flooding.

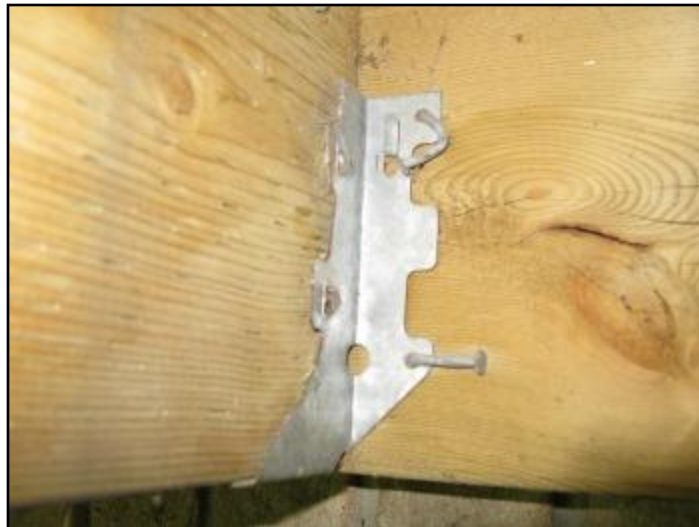
Condition: • [Fastener problems](#)

Joist hangers for wood deck are not properly secured.

Implication(s): Weakened structure | Chance of movement

Location: North Exterior Wall

4. Poor end bearing, joist hanger connections

Task: Improve

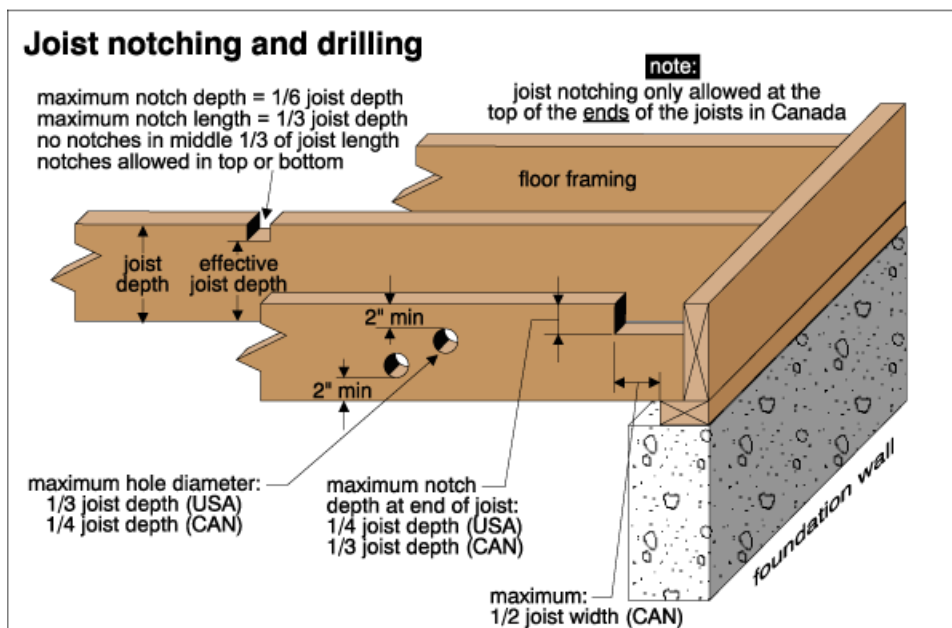
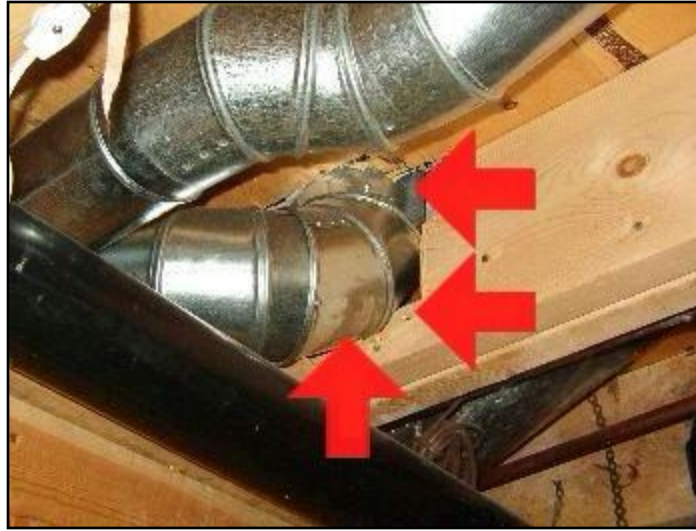
Condition: • [Notches or holes](#)

Previous repairs noted.

Implication(s): Weakened structure

Location: West

5. Joists are notched and weakened

Task: Repair

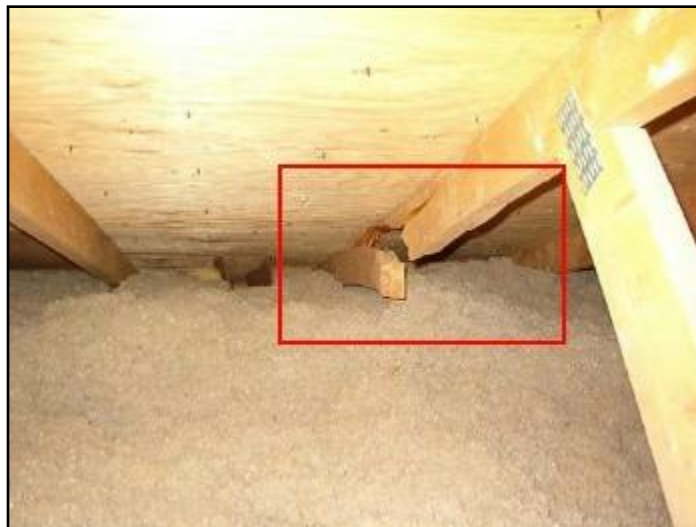
Condition: • [Split](#)

Implication(s): Weakened structure | Chance of structural movement

Location: North Attic

6. Top chord of truss is split

Truss repairs must be designed by an engineer.

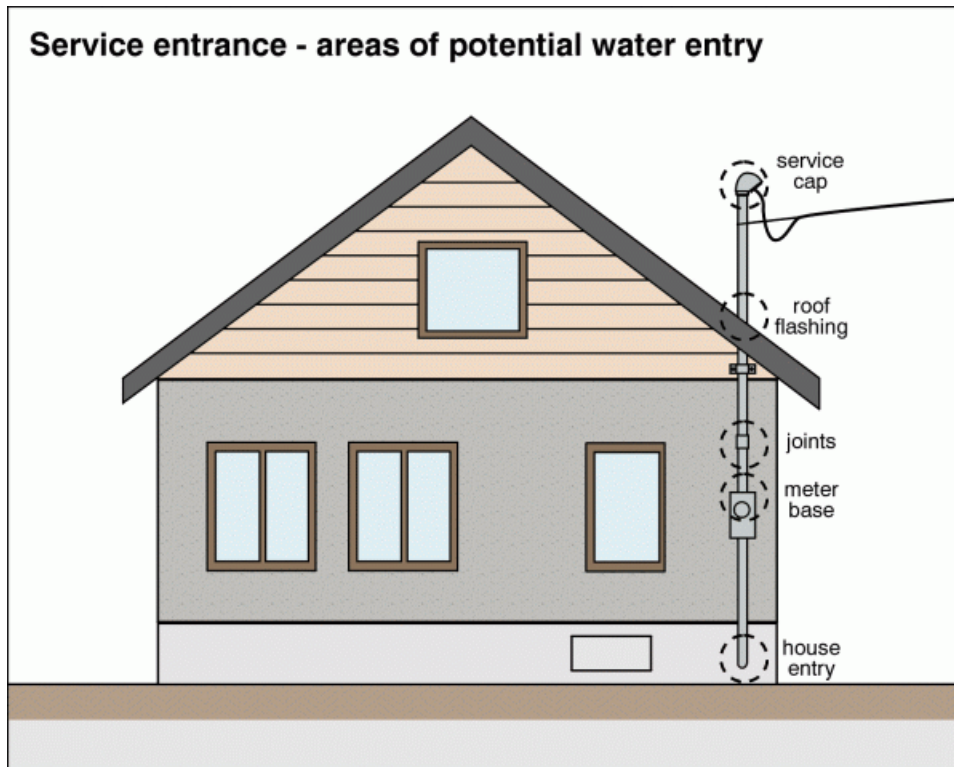
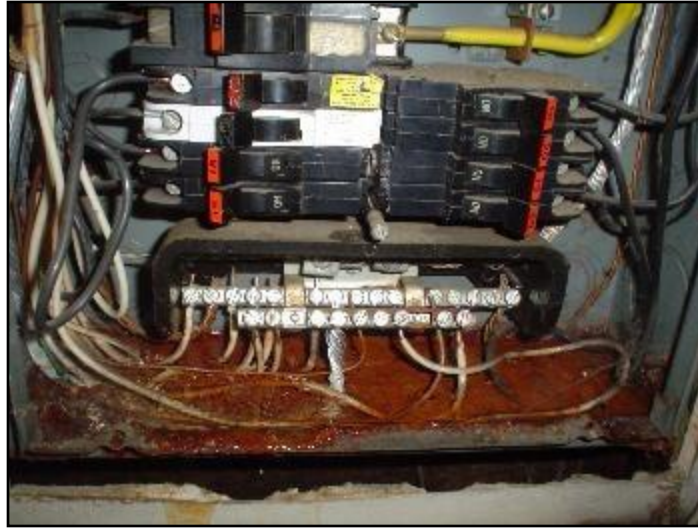
Condition: • [Rust or water in panel](#)

Implication(s): Electric shock | Fire hazard

Location: North Basement

7. Water and rust in bottom of panel

Task: Replace

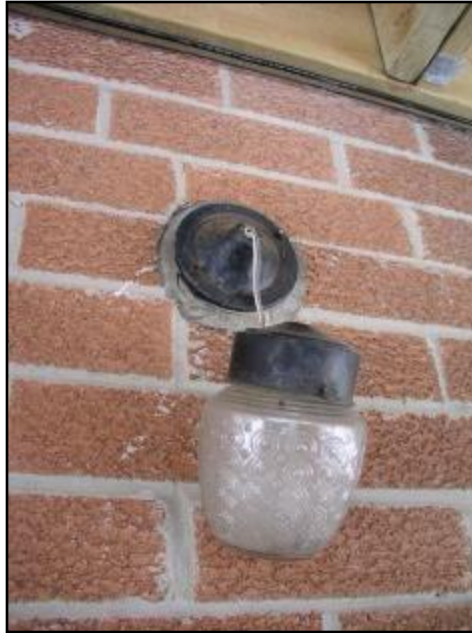
Condition: • [Loose](#)

Implication(s): Electric shock | Fire hazard

Location: East Exterior Wall

8. Light fixture is not well secured

Task: Repair or replace

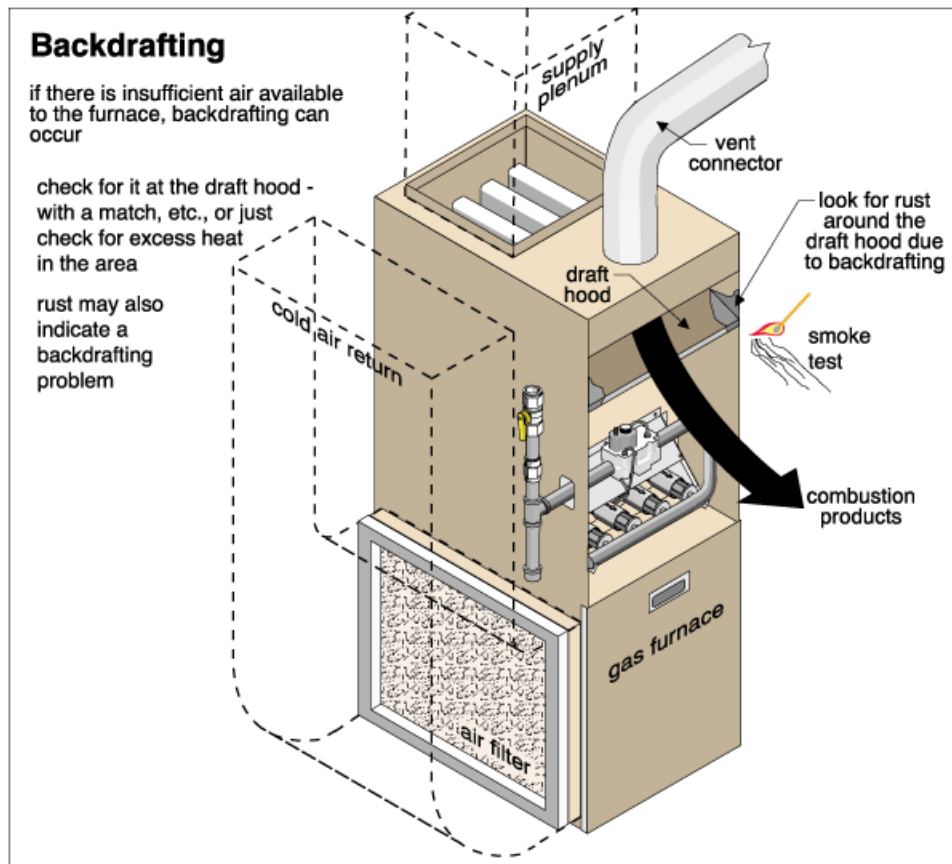
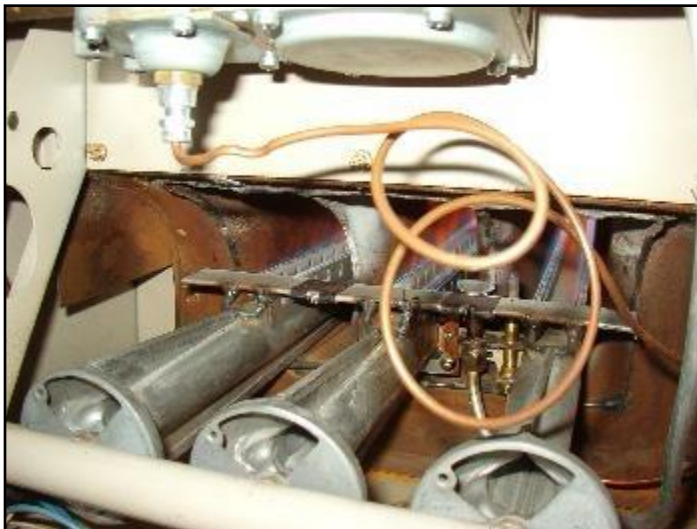
Condition: • [Draft hood spillage or backdraft](#)

A considerable amount of rust was noted on the front of the furnace.

This suggests a back-drafting problem, with combustion products entering the home.

Implication(s): Equipment not operating properly | Hazardous combustion products entering home

9. Draft hood spillage or backdraft

This is often caused by lack of combustion air, but the corrective action should be determined by a specialist.

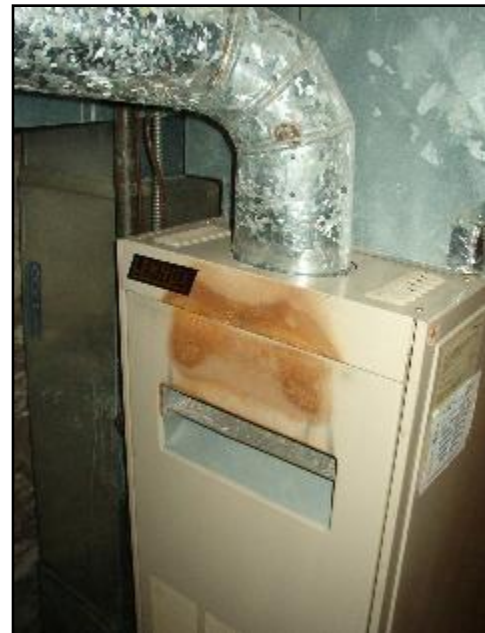
10. Draft hood spillage or backdraft

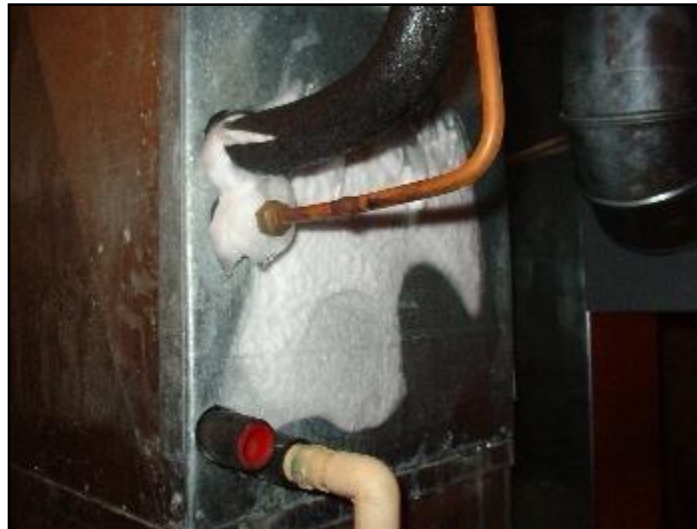
Condition: • [Frost](#)

Implication(s): Increased cooling costs | Reduced comfort

Location: West Basement

11. Frost

Task: Repair

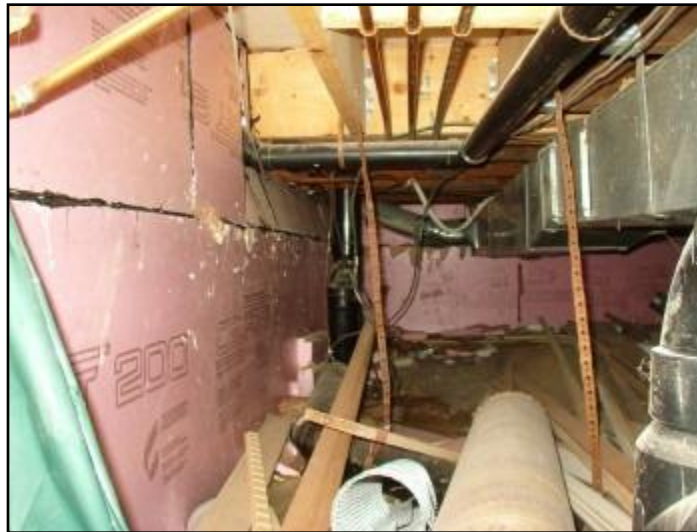
Condition: • [Exposed combustible insulation](#)

Implication(s): Fire hazard

Location: West Crawl Space

12. Exposed combustible insulation

Task: Remove or cover with drywall

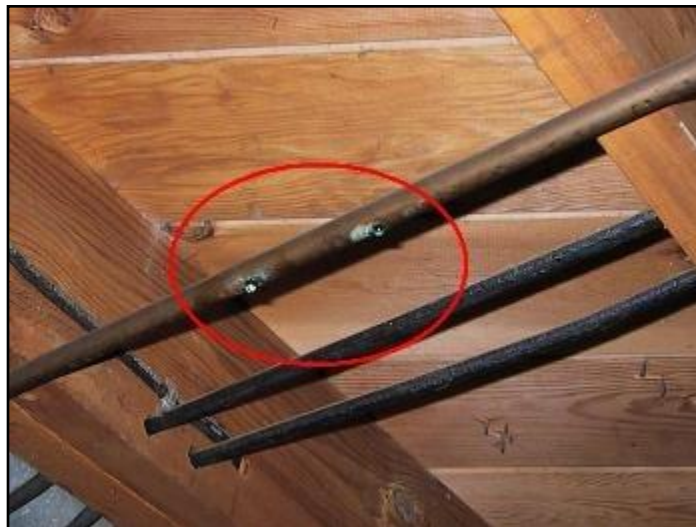
13.

Condition: • [Leak](#)

Location: Northeast Basement

Task: Replace

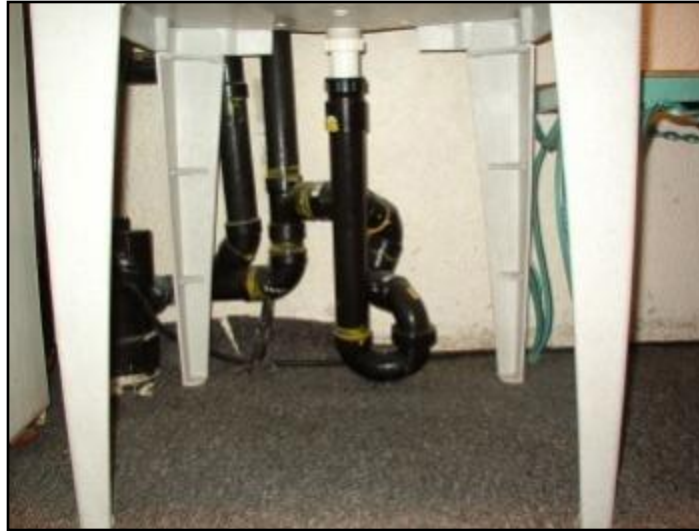
Condition: • [Nonstandard shape or material](#)

Implication(s): Reduced operability | Fixtures slow to drain

Location: Basement Laundry Area

14. Poor trap arrangement

Task: Improve

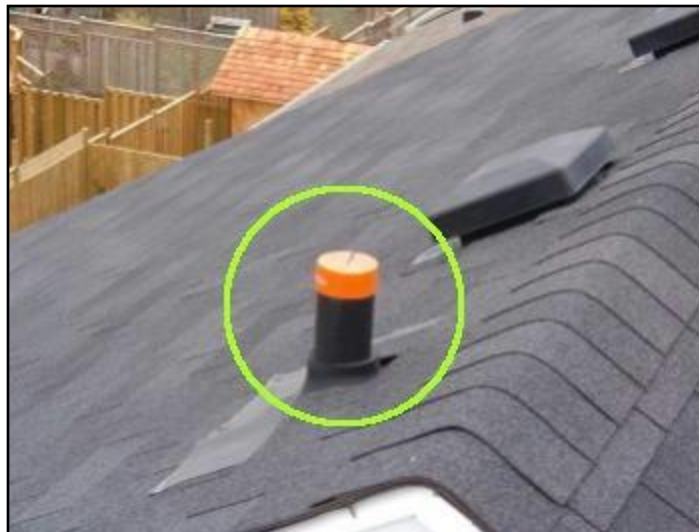
Condition: • [Vent termination problems](#)

Implication(s): Reduced operability | Sewer gases entering the building

Location: West central part of roof

15. Plumbing stack is capped

Task: Remove cap

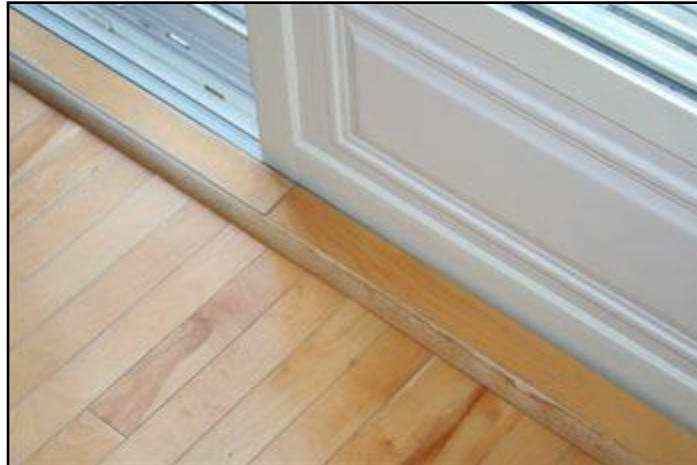
Condition: • [Stained](#)

Implication(s): Chance of water damage to structure, finishes and contents

Location: North First Floor Family Room

16. Stained

Task: Replace

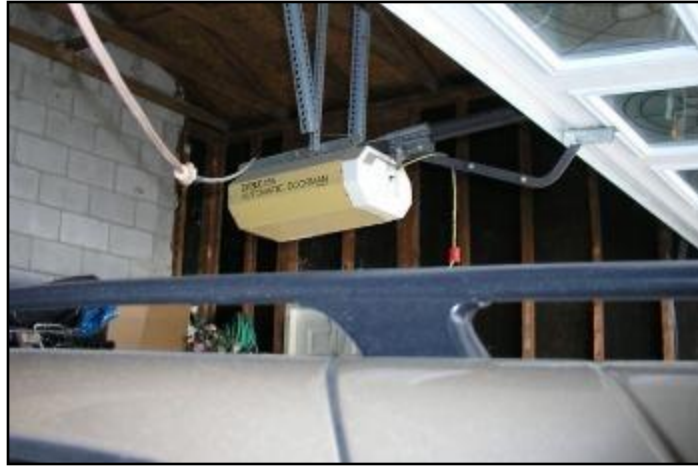
Condition: • [Extension cord for opener](#)

Implication(s): Electric shock

Location: Garage

17. Extension cord for opener

A dedicated receptacle (outlet) is recommended for the door opener.
